[Docket No. 92-CE-63-AD; Amendment 39-9251; AD 95-12-01]

Airworthiness Directives; Piper Aircraft Corporation PA-25 Series Airplanes

Appendix to AD 95-12-01—Procedures and Requirements for Wing Forward Spar Attachment Assembly; Inspection of Piper PA-25 Series Airplanes

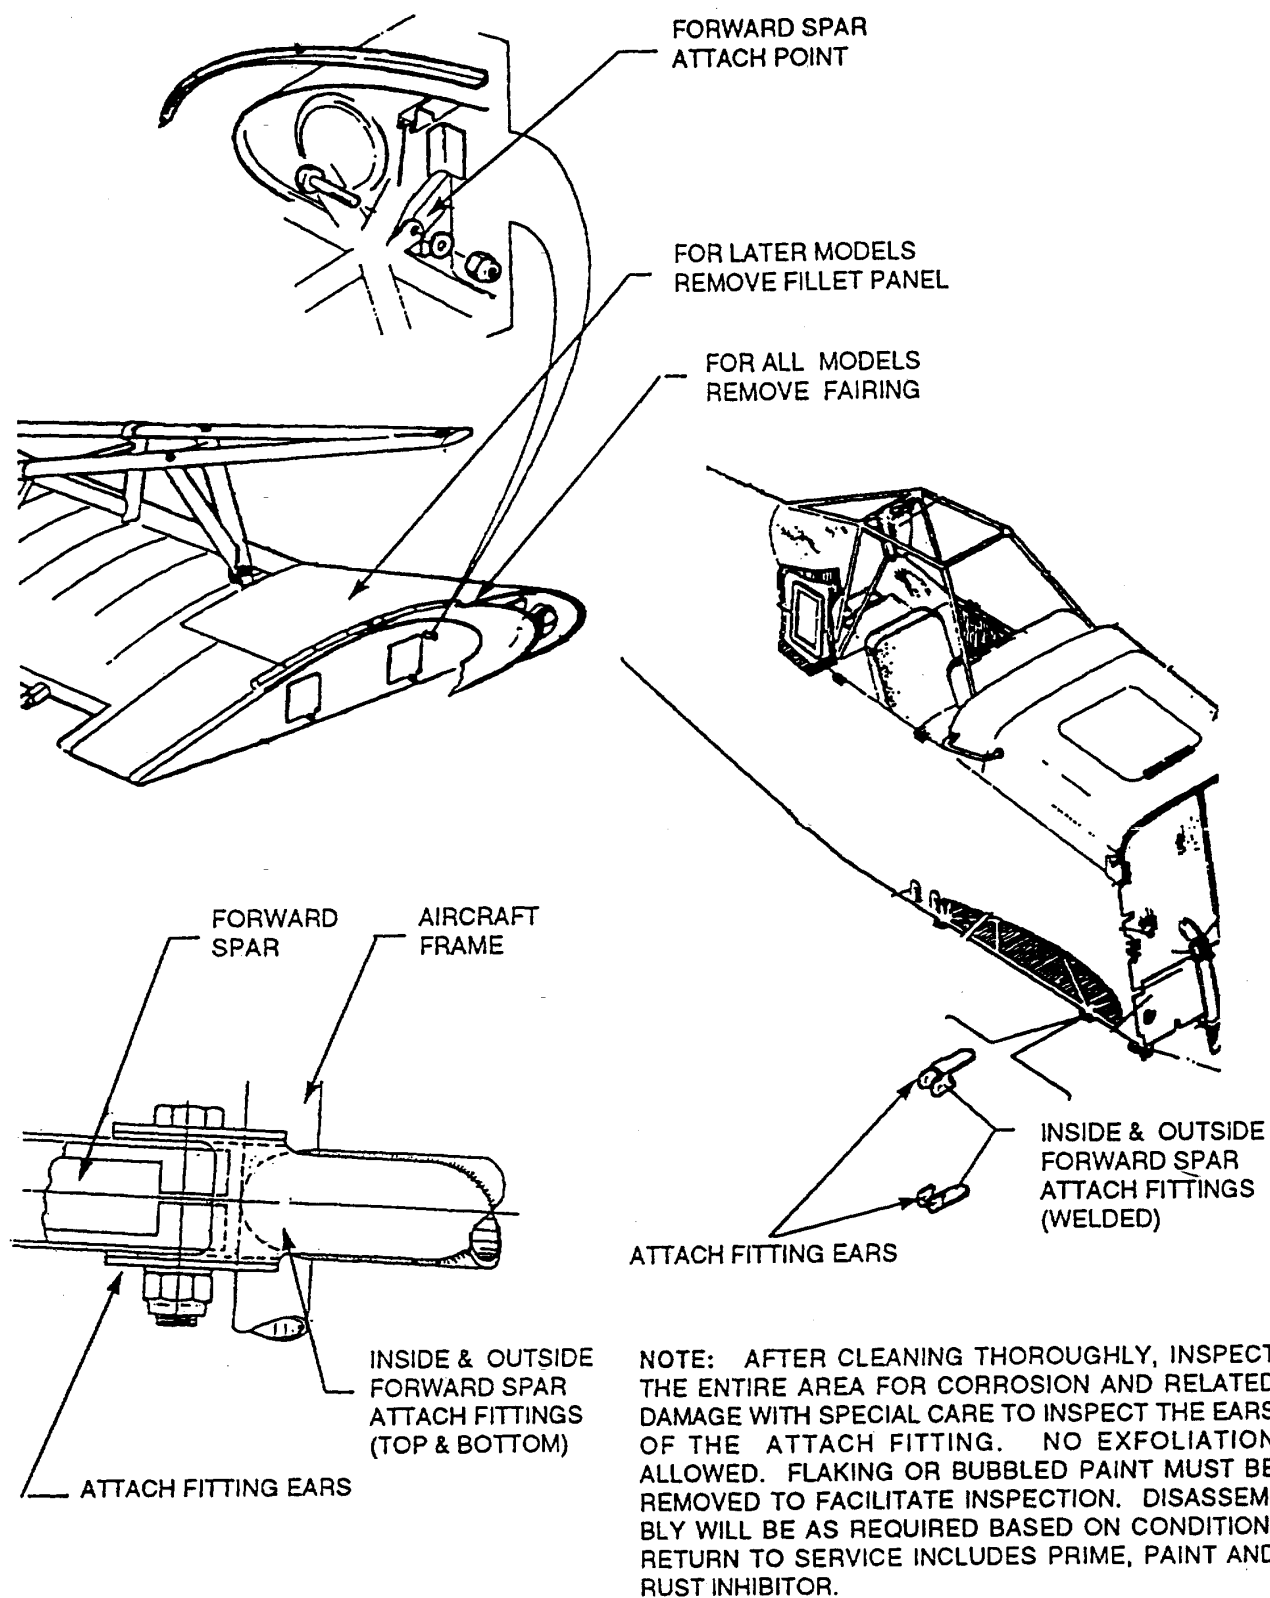
PA-25
Side View of the Front Wing Fitting
and Landing Gear Fittings

(a) Gain access to the left and right wing forward spar fuselage attach fittings by removing the screws retaining the wing fairing. Dismantle the wing fillet by removing the screws on the aft edge top and bottom and removing the wing fairing (see FIGURE 1 of the Appendix to this AD).

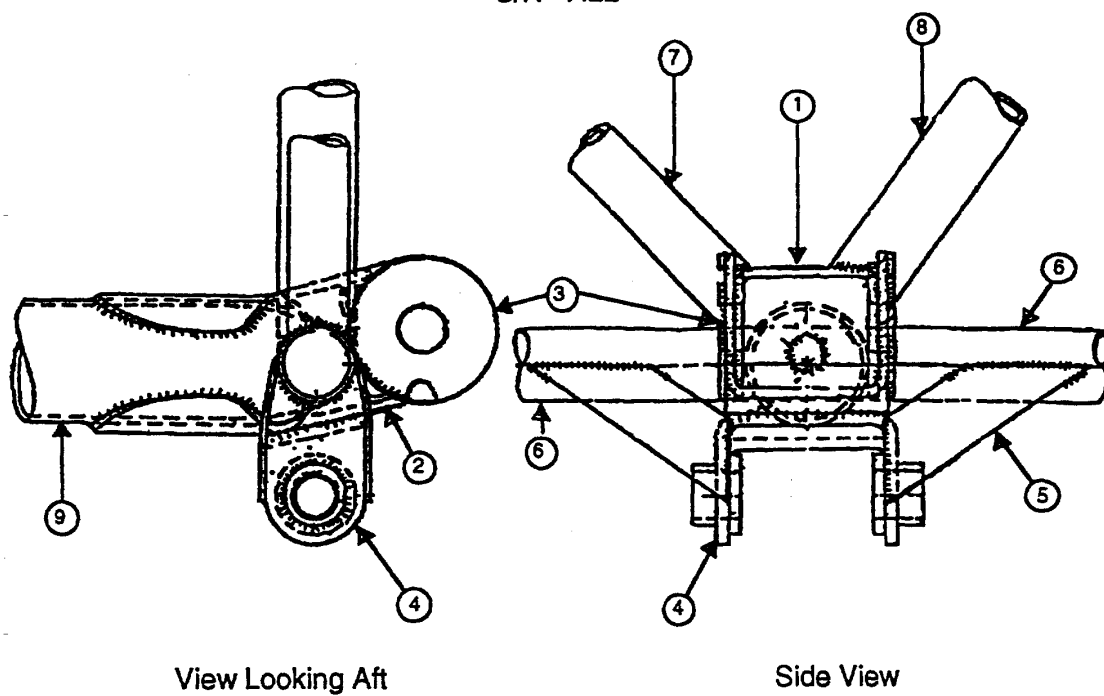
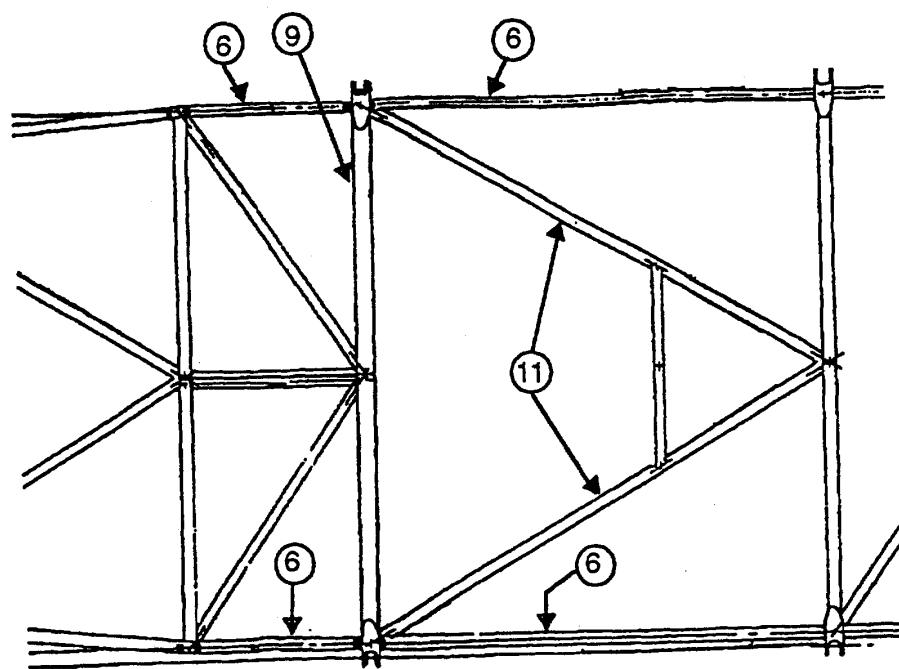
Figure 3a

1. Add couplant to the outside inspection surface (Refer to Figures 3a, 4a and 5a, as applicable). Add the appropriate gain to obtain the backwall echo from the inspection surface. If the gain setting is adjusted, re-check the thickness values on the steel shims. To assure proper coupling to the test sample, twist the probe clockwise and counter-clockwise (with a 45-degree twist) and maintain contact with the test surface. During the articulation of the probe, observe the A-trace on the screen and stop the probe twist at the point of adequate back surface signal amplitude to trigger the thickness gate

PA-25
S/N - ALL
Front Wing Spar Attachment-Fittings and Tubes

(e) Replacement parts required by this AD shall be of those referenced and specified in either Figures 3a and 3b, 4a and 4b, or 5a and 5b (as applicable), included as part of the Appendix of this AD.

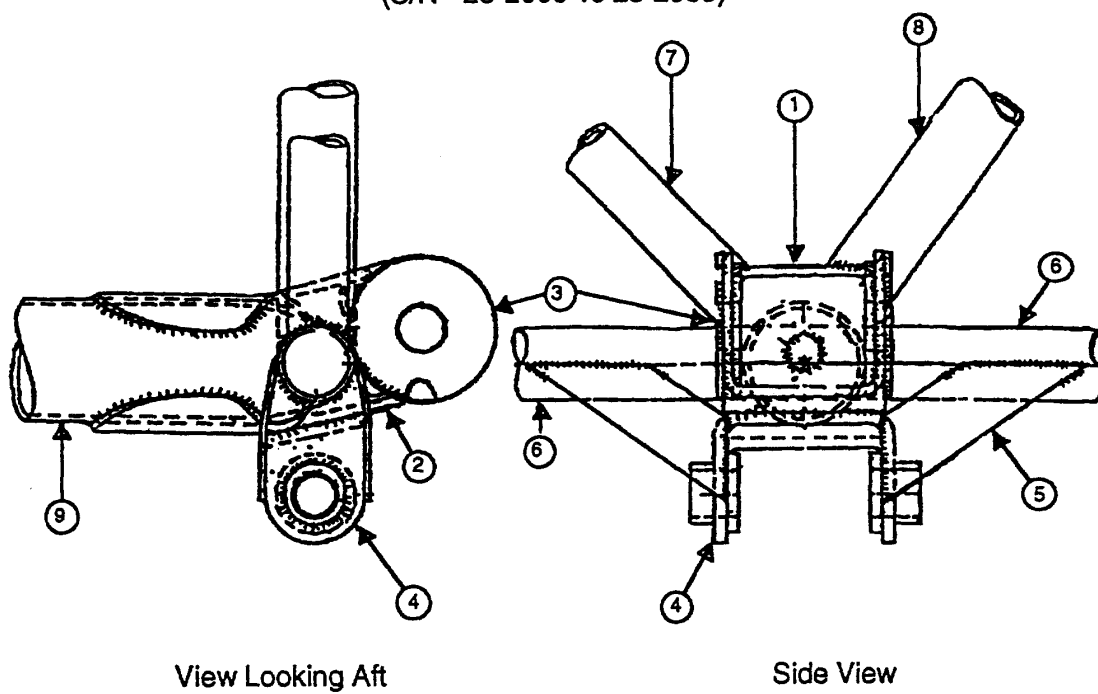
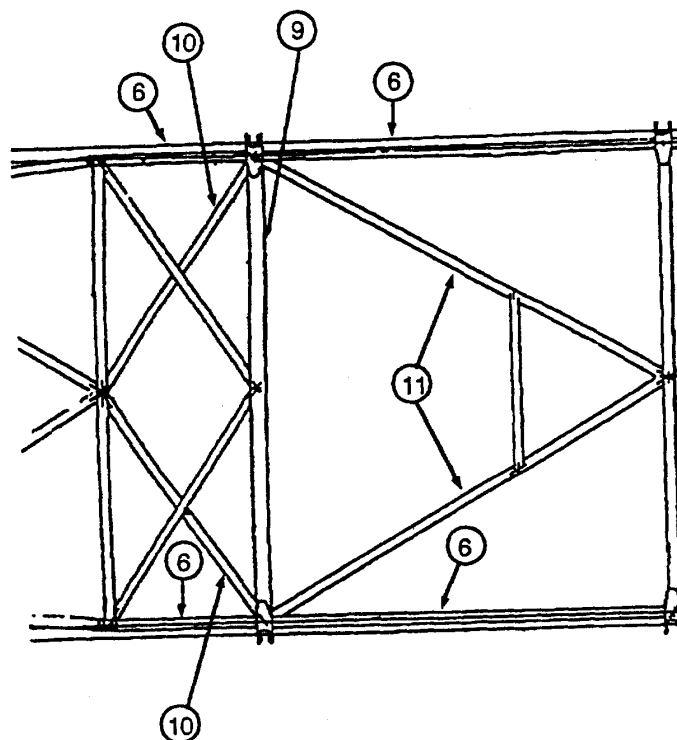
Figure 4a

Bottom View (View A-A)
(Both Sides)

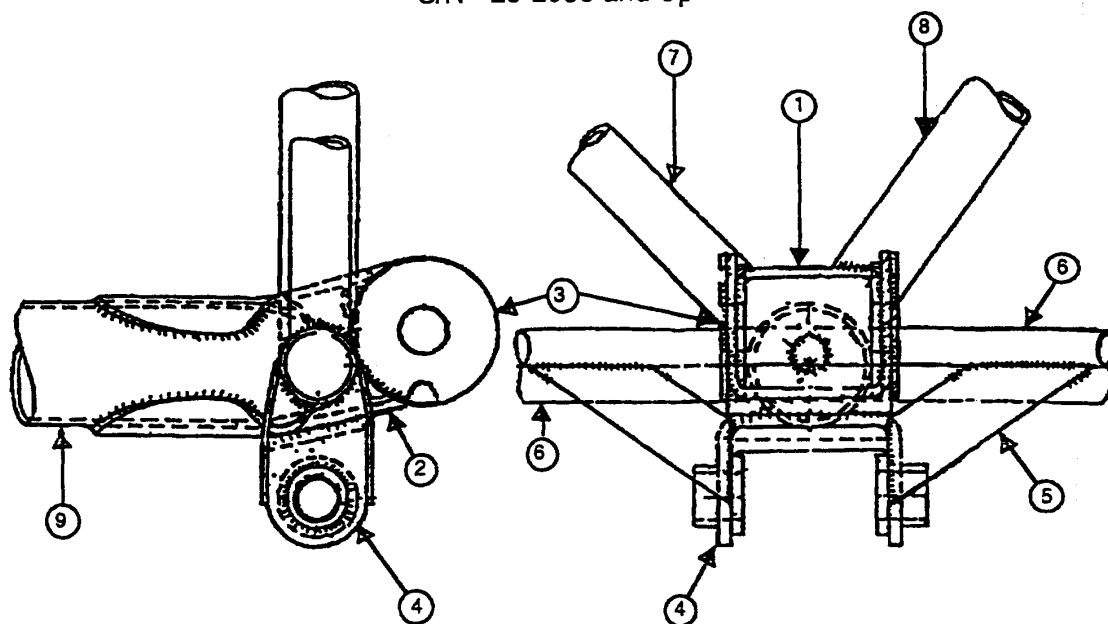
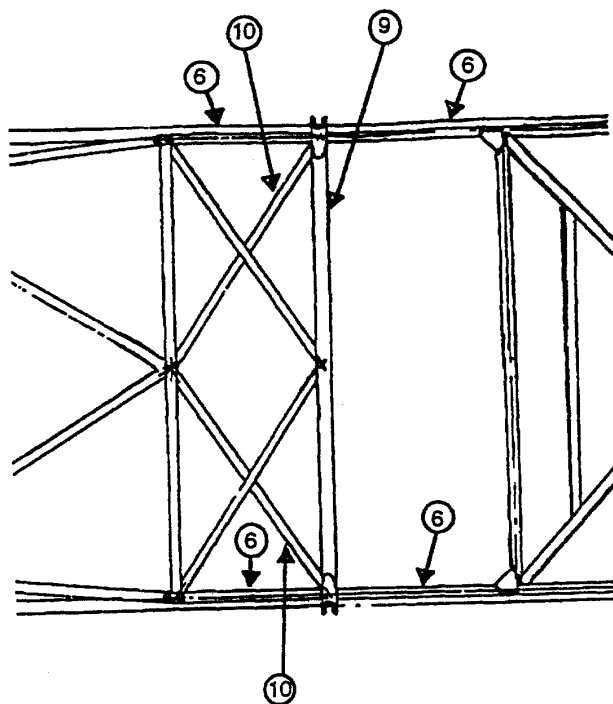
Figure 5a

Bottom View (View A-A)
(Both Sides)
